7272 Wisconsin Ave – LEED Case Study

Project Description

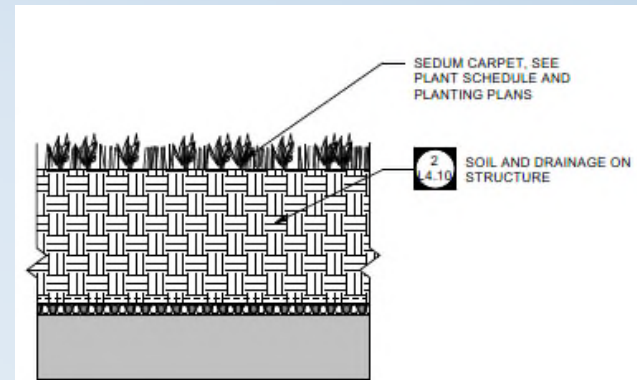
Image: Green Roof Detail

- The project has a 3,664 sf green roof and 6,218 sf of vegetated area which provides open space, contributes to tenant amenities and natural habitat.
- A reflective white roof with glacier white pavers combined with the green roof contribute to reducing the heat island effect.
- The stormwater management plan, which combines both green roof, and onsite bioretention, results in a 37% reduction in post-development runoff for the 2-yr 24 hr storm.
